**Seismic Vulnerability Assessment and Possible Strengthening  
Strategies for Traditional Bhutanese Rammed Earth  
Residential Houses**

**Phuntsho Wangmo**

A thesis submitted in partial fulfilment  
of the requirements for the degree of  
Doctor of Philosophy

Nagoya City University

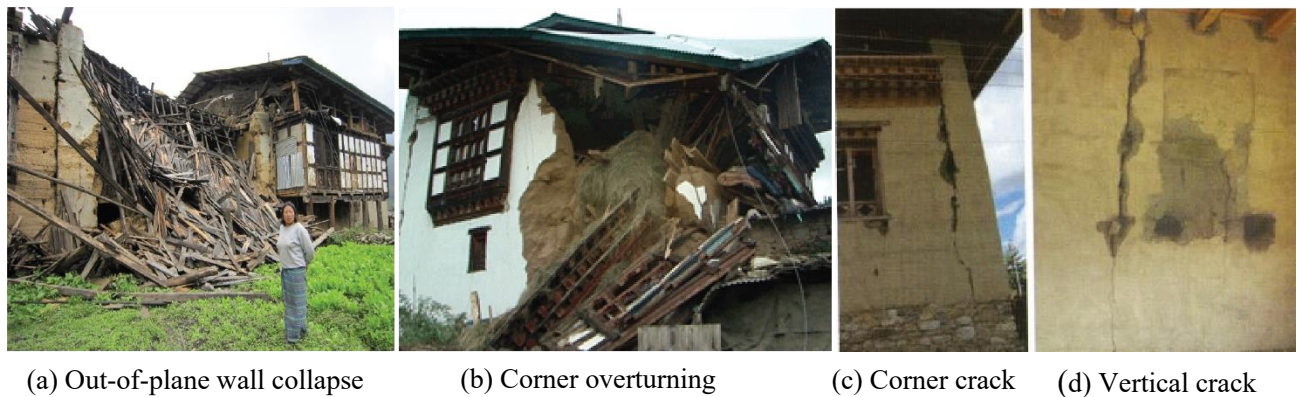
Figure 1.6 Rammed earth buildings damaged by the 2011 earthquake.

The survey undertaken by the Division for Conservation of Heritage Sites (DCHS) showed that the majority of the affected houses have vertical corner cracks (89%), separation at wall

intersection (58%), and cracks originating from the openings (73%) [10]. Some failure patterns observed in rammed earth houses are presented in Figure 1.6 [10,11].

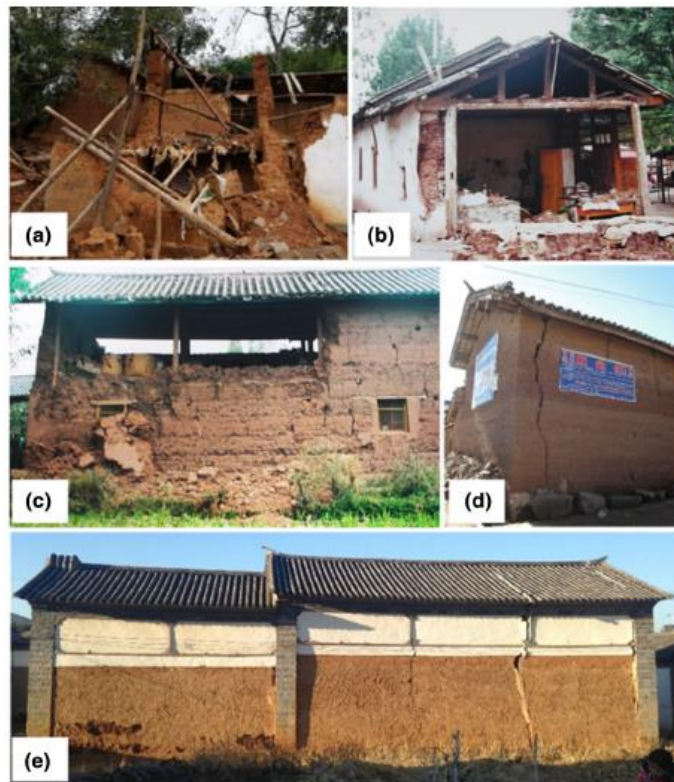
Figure 2.6 Damages observed in rammed earth houses: (a) structural collapse; (b) gable wall fall-over; (c) longitudinal wall fall-over, (d) vertical corner crack; (e) Crack at loading point [13].

intersection (58%), and cracks originating from the openings (73%). The survey was taken in the area where a maximum number of RE buildings were damaged. From the surveyed buildings, 26% of the rammed earth walls were reported as total collapse (out-of-plane). Some failure patterns observed are already presented in Figure 1.6 under Chapter 1. The collapse of the wall was either at the facade or at the corner. Similar damage patterns are reported for the rammed earth houses in rural Yunnan Province, China by Wang et al. [13], it is presented in Figure 2.6. Typical damages included out-of-plane fall over, vertical cracking at corners or at loading points.

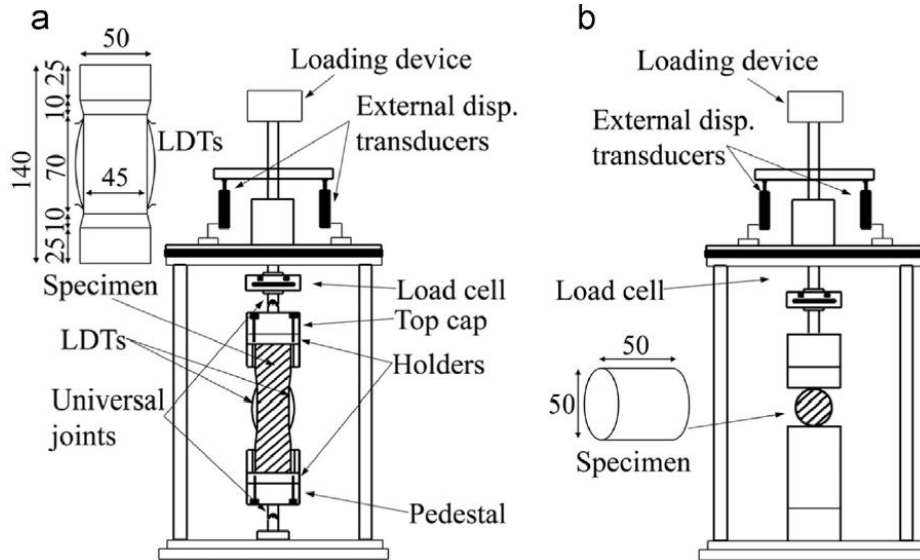
Figure 2.7 Specimens and apparatus for: (a) Direct tension test; (b) Splitting test [28].

directly tensioned until it reaches failure. In splitting tensile test, a cylinder specimen is loaded uniformly in compression along the length. This condition creates tensile forces perpendicular to the loading direction and one can evaluate the tensile strength indirectly.

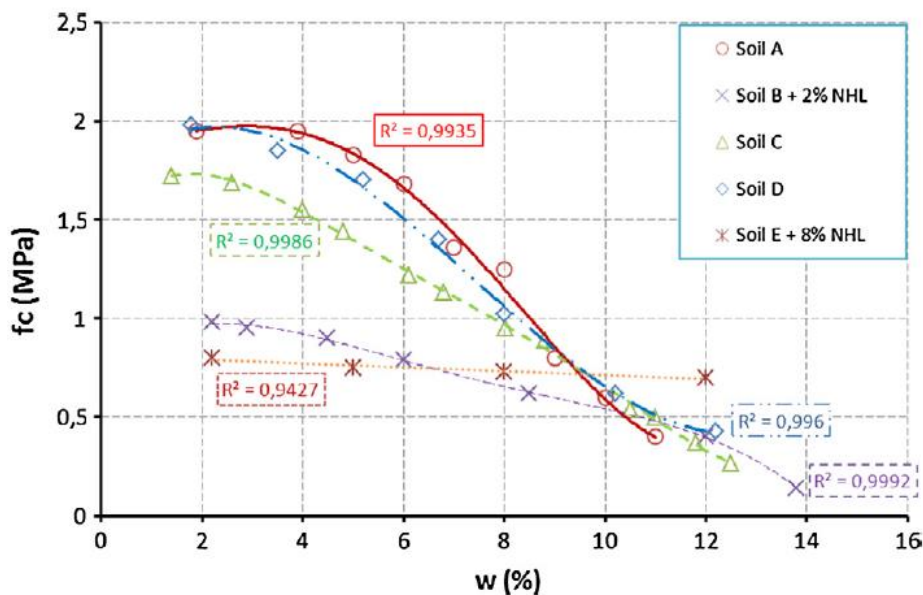
Figure 2.11 Variation of compressive strength with moisture content [30].

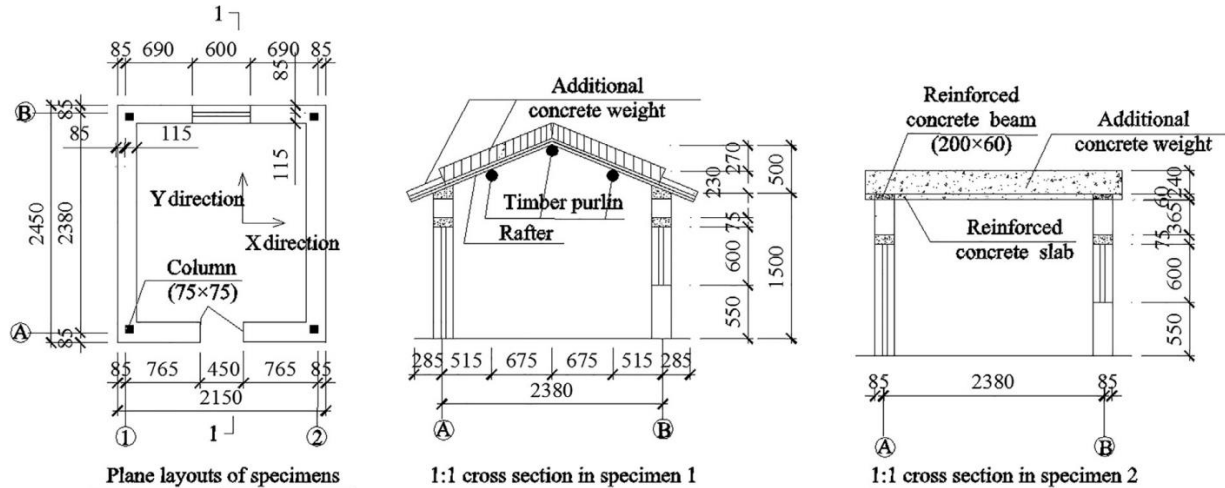
Figure 2.18 Proposed seismic measures for new construction [42].

Another seismic measure proposed, which includes employment of reinforced concrete (RC) beams and columns inside the RE wall, transforming the load-bearing mode of RE buildings to the RC structures [42], the details are presented in Figure 2.18. These inner RC structures enabled the RE buildings to undertake extra earthquake actions even after the building attained elastic-plastic stage or complete destruction condition. The proposed technique is more realistic for Bhutanese rammed earth considering the materials are available in the local market. However, reducing the size of RC sections can reduce the cost. Also, avoiding the stirrups in the vertical post can save both time and cost. Despite its advantages, the placement of the aforementioned reinforcements in rammed earth wall can be cumbersome, and proper compaction may not be achieved around those components. Thus, extra attention should be paid during the construction to avoid such compromise while ramming.

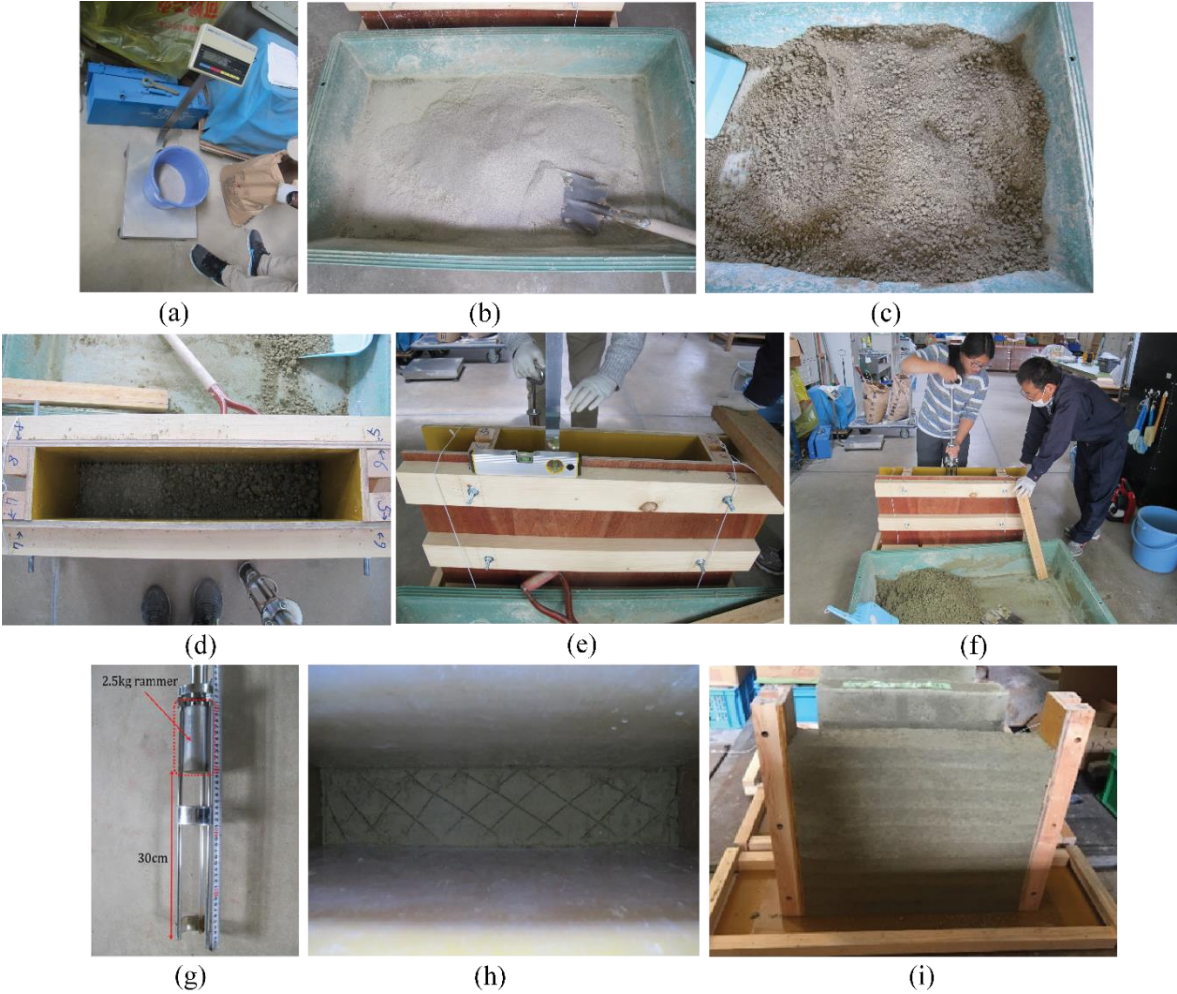
Figure 3.5 Specimen preparation process.

completed layer, as shown in Figure 3.5(h), to have proper bonding with the next layer. The process is repeated until one complete specimen is manufactured. The formwork is then removed, allowing the specimen to dry, as shown in Figure 3.5(i). The specimens were kept inside a room having a minimum temperature of 11.2 °C and a maximum of 30.6 °C. The minimum relative humidity recorded was 29%, and the maximum was 85%. The temperature and humidity data for one year is presented in Figure 3.6.

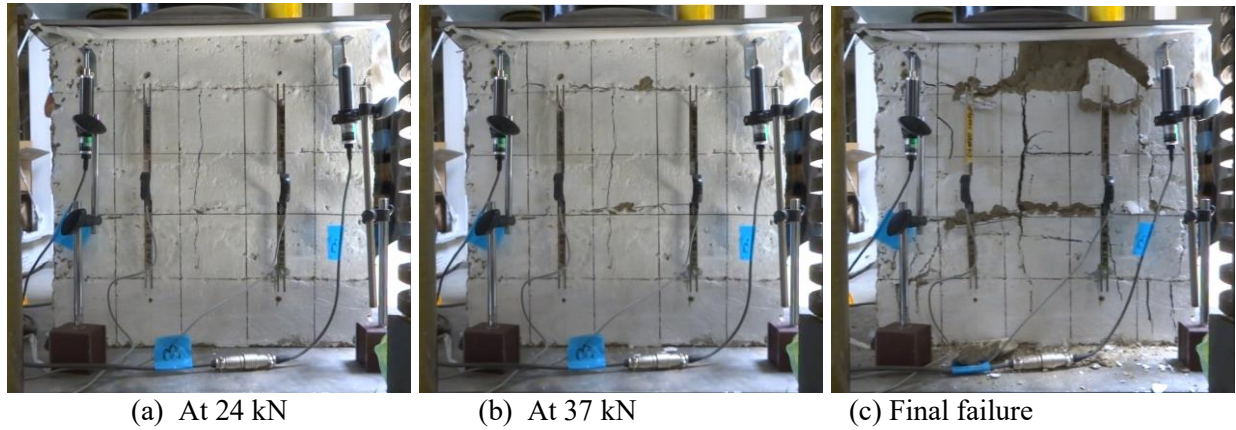
Figure 3.16 Failure pattern of U-100-C3-1.

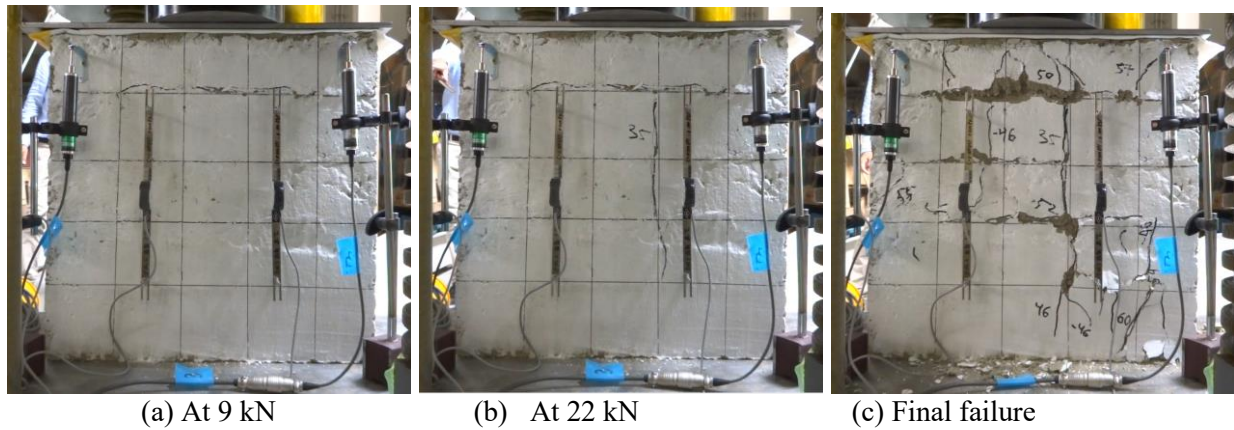
Figure 3.17 Failure pattern of U-100-C3-2.

Figure 3.17. The peak strength recorded at the failure was 0.92 MPa which is close to the strength of 1<sup>st</sup> wall.

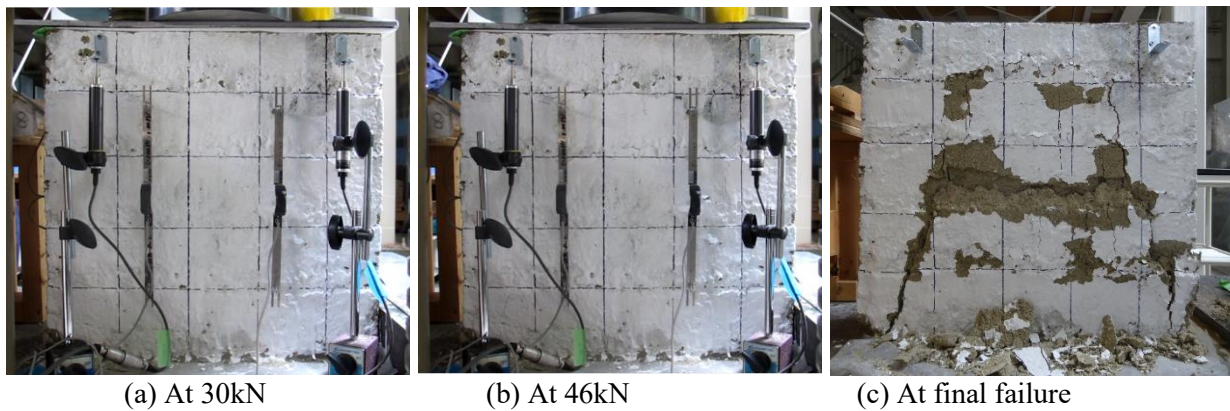
Figure 3.19 Failure pattern of U-100-C12-1.

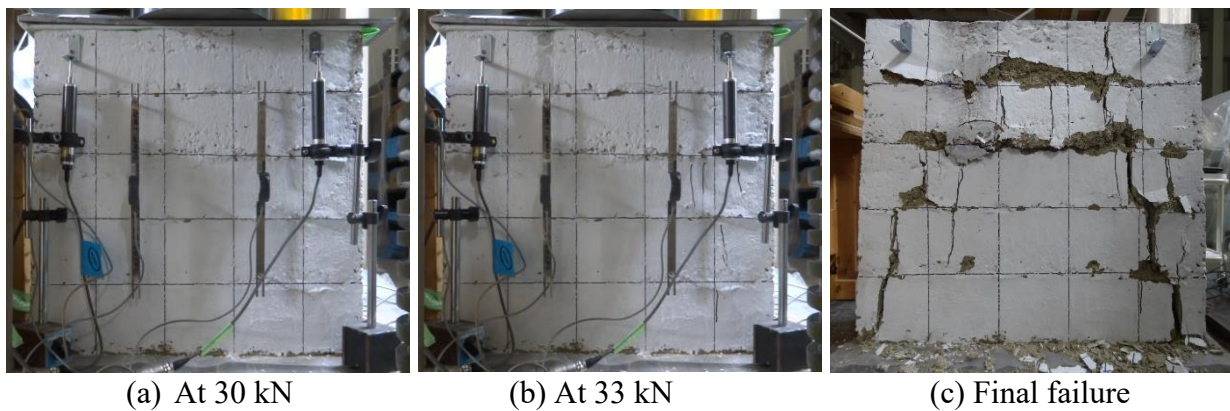
Figure 3.20 Failure pattern of U-100-C12-2.

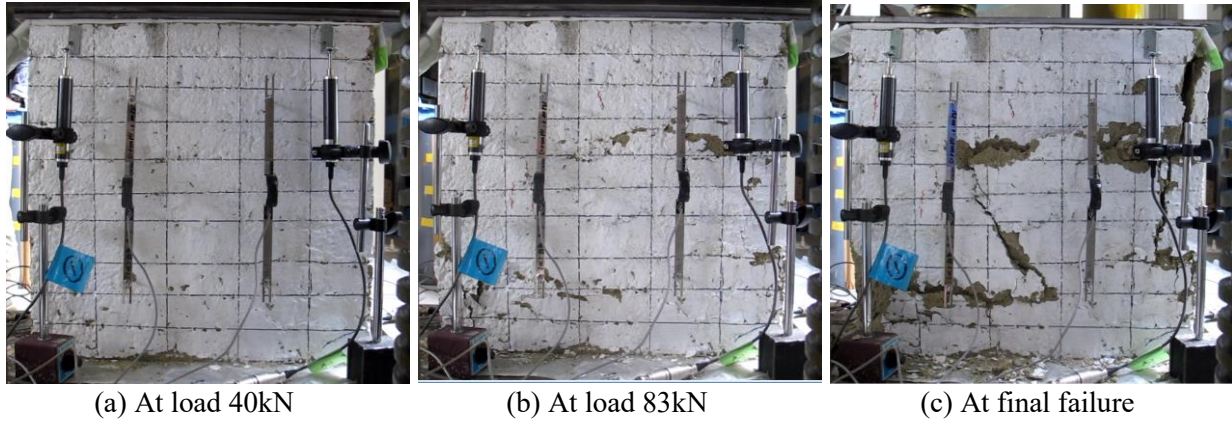
Figure 3.25 Failure pattern of U-50-C12-1.

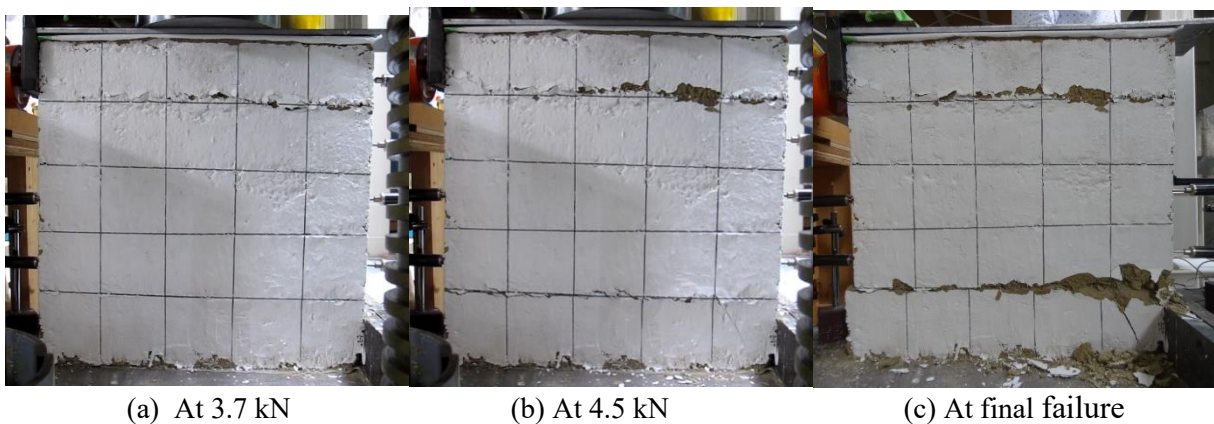
Figure 3.38 Failure pattern of U-100-S12-0.1.

The mode of failure observed in each specimen is presented in Figure 3.38 for U-100-S12-0.1, Figure 3.39 for U-100-S12-0.15 and Figure 3.40 for U-100-S12-0.2. For specimen U-100-S12-0.1, a rocking was observed in the initial stage. The first horizontal crack appeared between 4<sup>th</sup> and 5<sup>th</sup> layer at 3.7 kN. Around 4.5 kN, a horizontal crack between 1<sup>st</sup> and 2<sup>nd</sup> layer was also noted. The wall failed with sliding along the weakest layer (the layer between 1<sup>st</sup> and 2<sup>nd</sup>). A similar failure mode was observed in U-100-S12-0.15 with rocking at the initial. Parts of earth started falling between 4<sup>th</sup> and 5<sup>th</sup> layer interface when the horizontal load was around 5.5 kN. A tension cracking was observed between 1<sup>st</sup> and 2<sup>nd</sup> layer at 6.2 kN followed by the horizontal crack between 2<sup>nd</sup> and 3<sup>rd</sup> layer. The wall failed with a slip of layer and forming a diagonal crack. For specimen U-100-S12-0.2, there was crushing between layers (4<sup>th</sup> and 5<sup>th</sup> followed by at 2<sup>nd</sup> and 3<sup>rd</sup> layer) due to vertical stress applied. A diagonal crack was formed at the final failure.

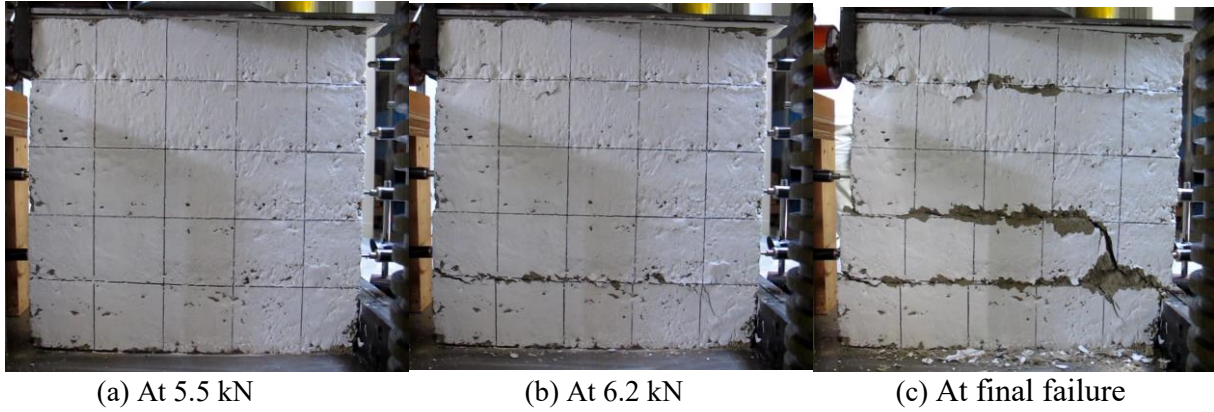
Figure 3.39 Failure pattern of U-100-S12-0.15.

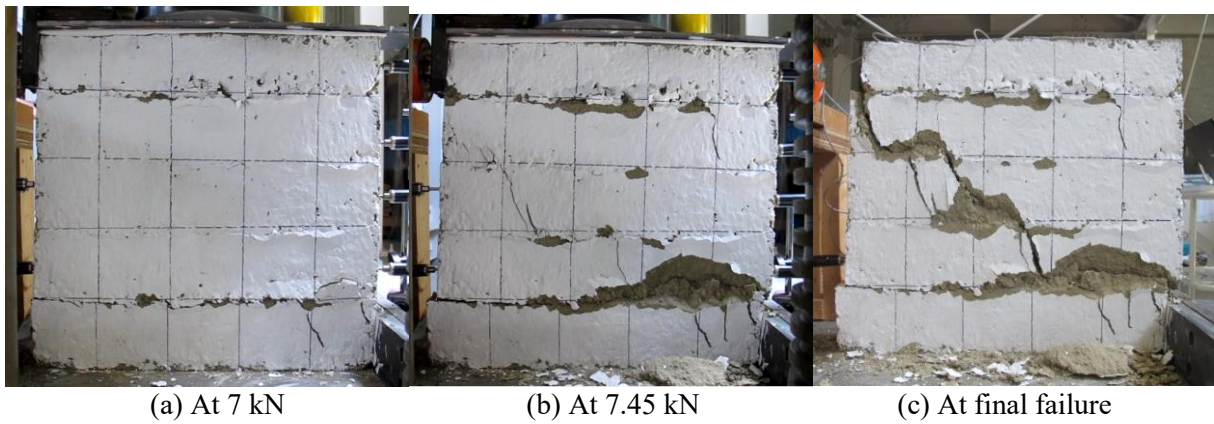
Figure 3.40 Failure pattern of U-100-S12-0.2.

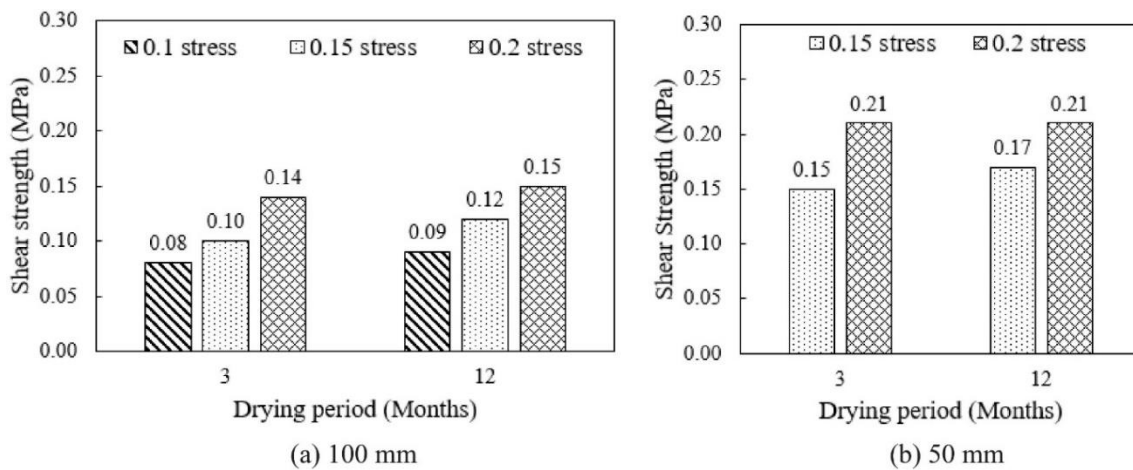
Figure 3.49 Shear strength of RE wallettes with varying drying periods.

Figure 3.49(a) presents the recorded shear strength for 100 mm layer RE wall with drying period of three months and twelve months subjected to vertical stress 0.1 MPa, 0.15 MPa, and 0.2 MPa. These values for 50 mm layer RE wallettes are presented in Figure 3.49(b). However, the vertical stresses for 50 mm layer RE wallettes are limited to 0.15 MPa and 0.2 MPa since rocking behaviour was noted at lower vertical stress of 0.1 MPa. For 100 mm layer RE wall, the shear strength increases with the increase in the drying period; however, the percentage increase varies with the

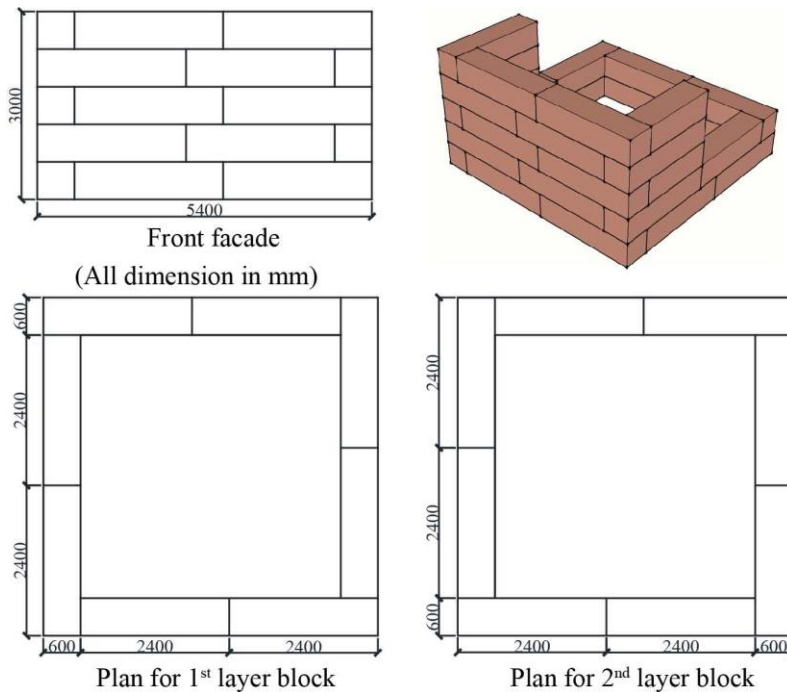
Figure 4.1 Details of U-RE.

The unreinforced rammed earth wall (U-RE) was constructed following the construction procedure practised in Bhutan. The details of the dimension and configuration of U-RE wall considered for the test is presented in Figure 4.1. The wall had a total of five blocks in vertical, where each block had 600 mm thick in height. The wall's configuration follows the typical typology of traditional Bhutanese house where the first floor has a solid wall, and the second floor has a large opening in the front façade. In the present wall sample, first two layers' block represented the first floor, and three other blocks above them represented the second floor. Locally available red clay with small pebbles was used for the rammed earth wall construction. Before the construction of

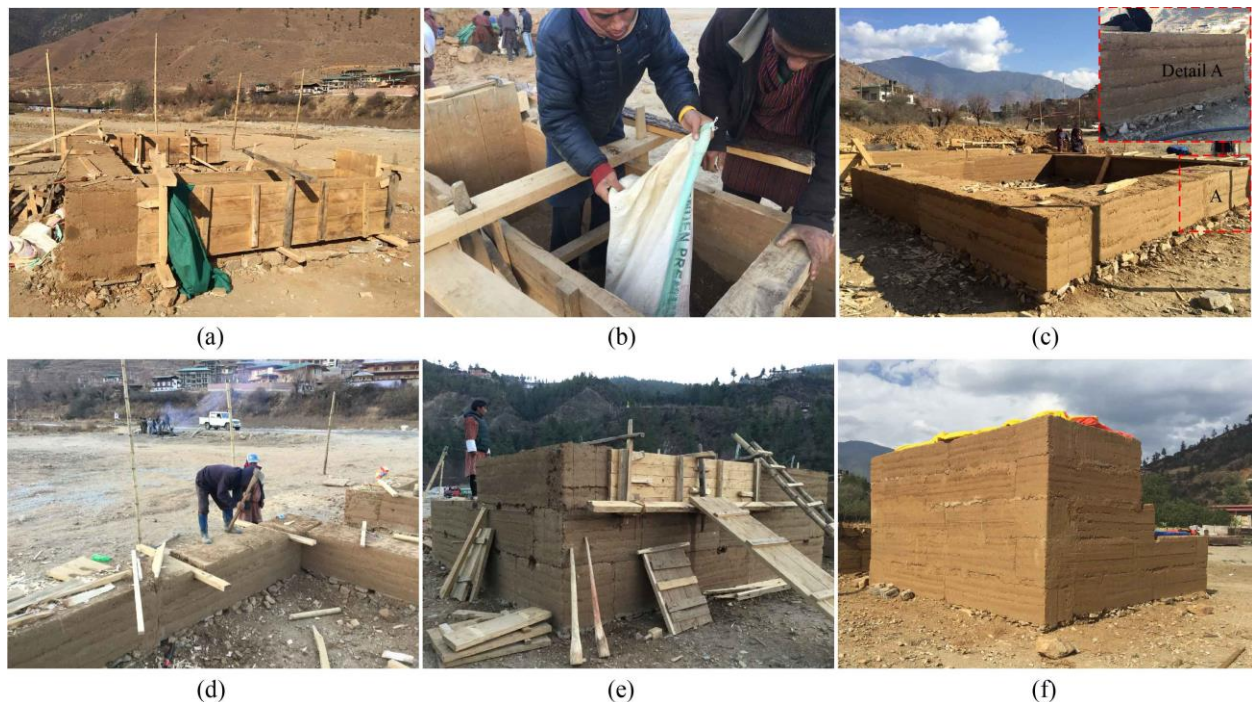
Figure 4.2 Construction process details of U-RE.

rammed earth wall, a stone foundation is laid as generally seen in the traditional houses to avoid water ingress to the main wall. The process of construction is illustrated in Figure 4.2. The first step includes the installation of wooden formwork, as shown in Figure 4.2(a). The formwork consisted of i) shutter planks on both sides, ii) horizontal joining members on top and bottom, iii) vertical members to connect the shutter planks and horizontal members. Wedges were also inserted between the vertical members and shutter planks to keep the formwork stable, thus preventing wall bulging. This single formwork section gave a rammed earth block of around 250 cm length, 60–70 cm height and 60 cm thickness. Next, soil/red clay, brought on bags, was poured inside the space within the formwork, followed by manual ramming using ramming tools. The ramming usually lasted 30 minutes to 1-hour to complete one block. The final finished block looked smooth and shiny, indicating the sufficient hardness achieved. One block consisted of five layers, as shown in Detail A of Figure 4.2(c). Here, approximately 240 mm of soil was compacted to 120 mm for a single layer. After completing each section or block, the formwork was removed immediately and re-installed to construct the next section of the wall. Figure 4.2(c) shows the completion of the 1<sup>st</sup> block level. To prepare for the next block layer, a section from the lower block's top surface was cut to fit the bottom horizontal members of the formwork, as seen in Figure 4.2(d). And the process of installation of formwork and ramming the clay is repeated till the completion of specimen.

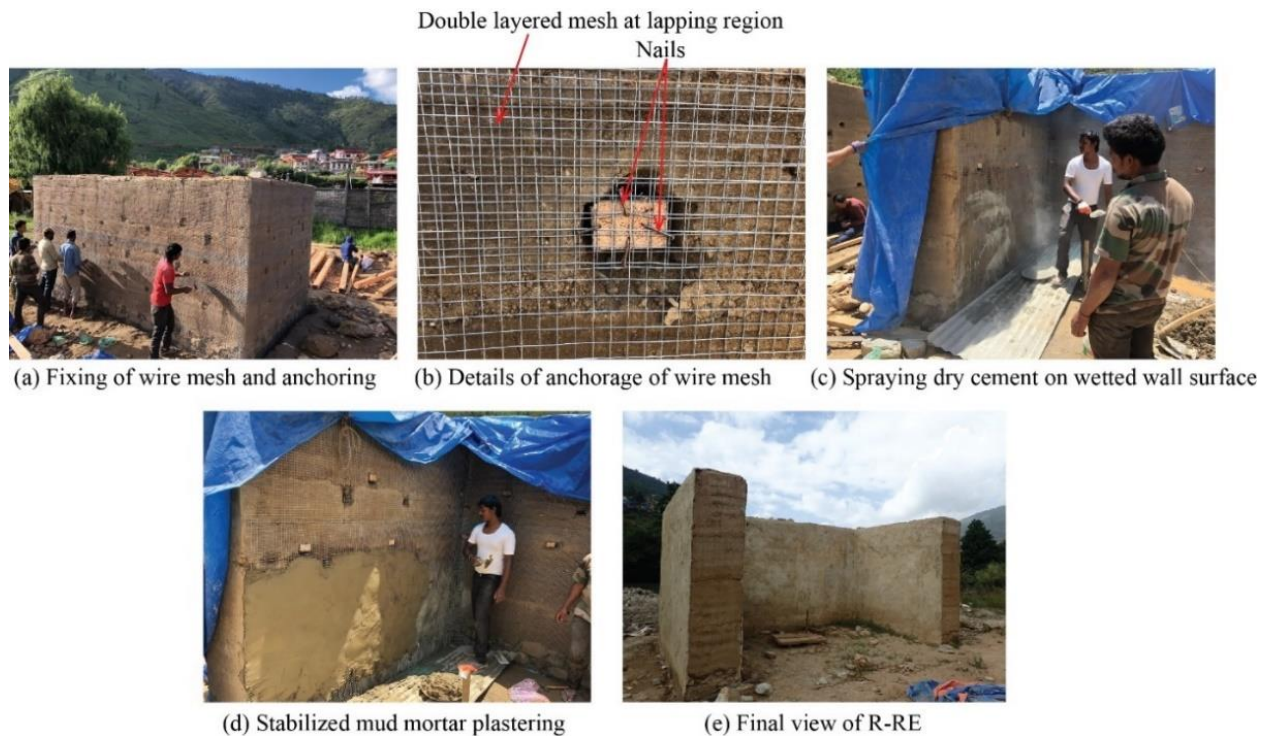
Figure 4.6 Construction details of retrofitted rammed earth specimen (Mesh-RE).

*jugshings* (lower horizontal member of formwork). To avoid local failure at the mesh joints, a lapping length of 200 mm was provided both in the horizontal and vertical direction. Before applying the mortar, the wall was adequately moistened with water, and dry cement powder was sprayed as illustrated in Figure 4.6(c). The final retrofitting work included plastering 30 mm thick stabilized mud plaster (1cement:4mud) over the mesh, as shown in Figure 4.6(d). The retrofitting work was completed in August 2018. The specimen was then allowed for curing for approximately one month after the mesh retrofitting work.

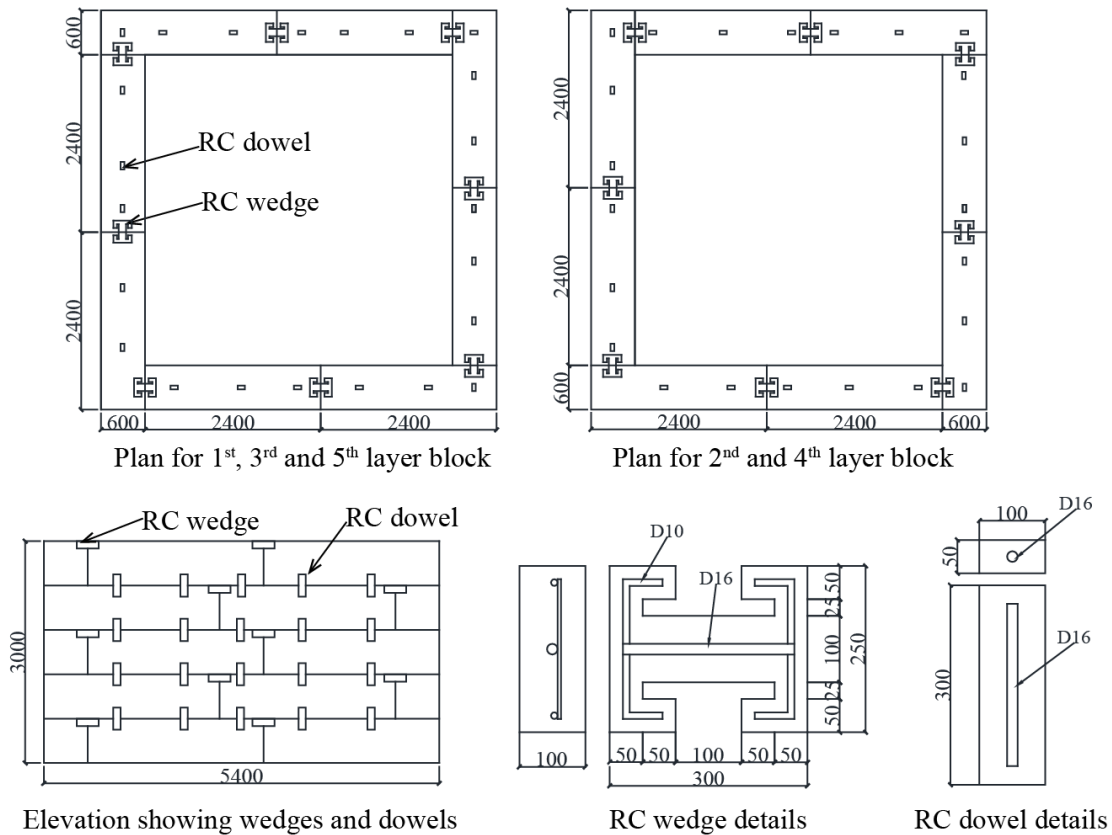
Figure 4.9 Details of reinforced rammed earth specimen of New-RE-A.

The RC wedges and RC dowels were introduced in between the blocks to improve the wall's integrity. The details of RC wedges and RC dowels are presented in Figure 4.9. The figure also presents the details of their placement on the wall. Such strengthening measures are inspired by the indigenous reinforcing method by placing horizontal reinforcement members like timber and flat stone over the joint blocks to avoid a vertical crack in weak areas like holes created by removal of Jugshing (Figure 4.10). A similar strengthening technique with floor anchorage system where wooden floor joist are anchored to the rammed earth wall is described in details elsewhere [4].

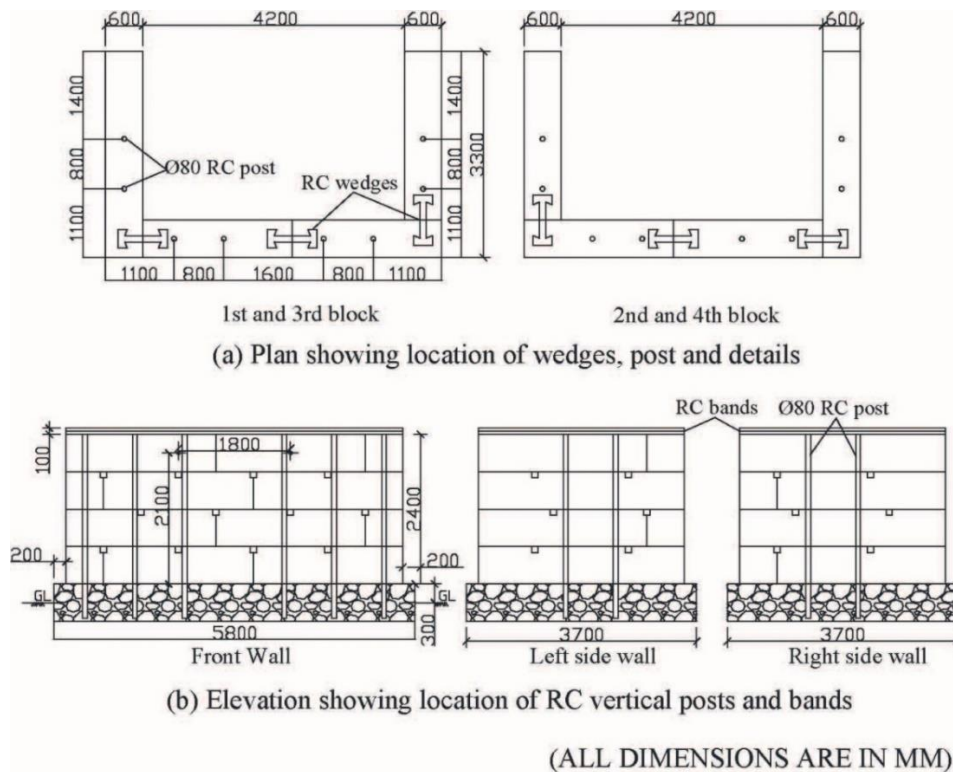
Figure 4.12 Details of reinforced rammed earth specimen (New-RE-B).

The specimen was constructed with the same soil properties used for the construction of the unreinforced specimen. However, the geometry of the current specimen is slightly modified from the previous specimens U-RE and New-RE-A. The wall has a U-shaped configuration, the front wall represent the main longitudinal wall, and two side walls represent the transverse wall. The wall has 5.4 m length, 2.4 m height and 0.6 m thickness, the average thickness found in traditional rammed earth houses in Bhutan. The wall consists of four layers of the block with each block having dimension 2.4 m length, 0.6 m height and 0.6 m thickness. Furthermore, within the block constituted five-layer having thickness ranging from 0.11-0.13 m. The details of the reinforced rammed earth specimen (New-RE-B) is presented in Figure 4.12, showing the reinforcing RC elements.

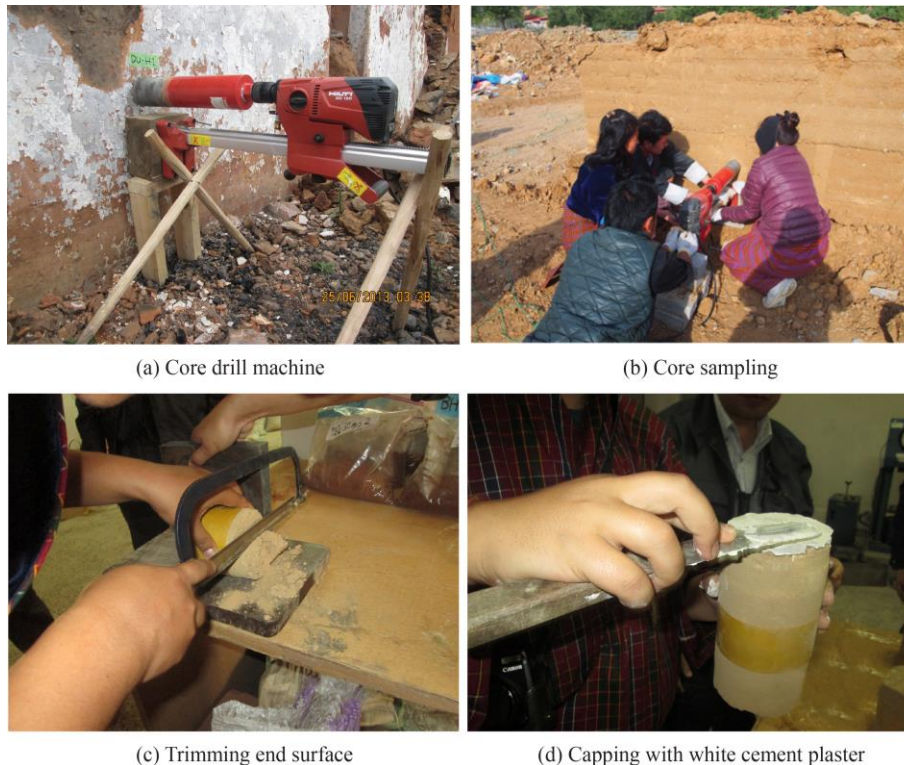
Figure 4.18 Sample collection for the material test.

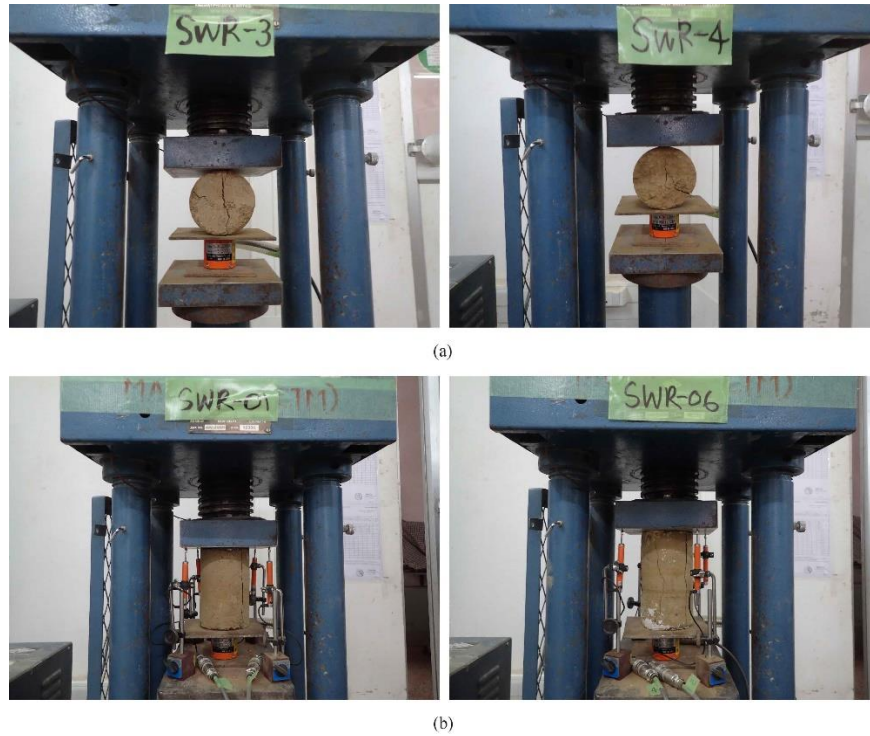
Figure 4.21 Failure patterns observed: (a) Tensile test; (b) Compression test.

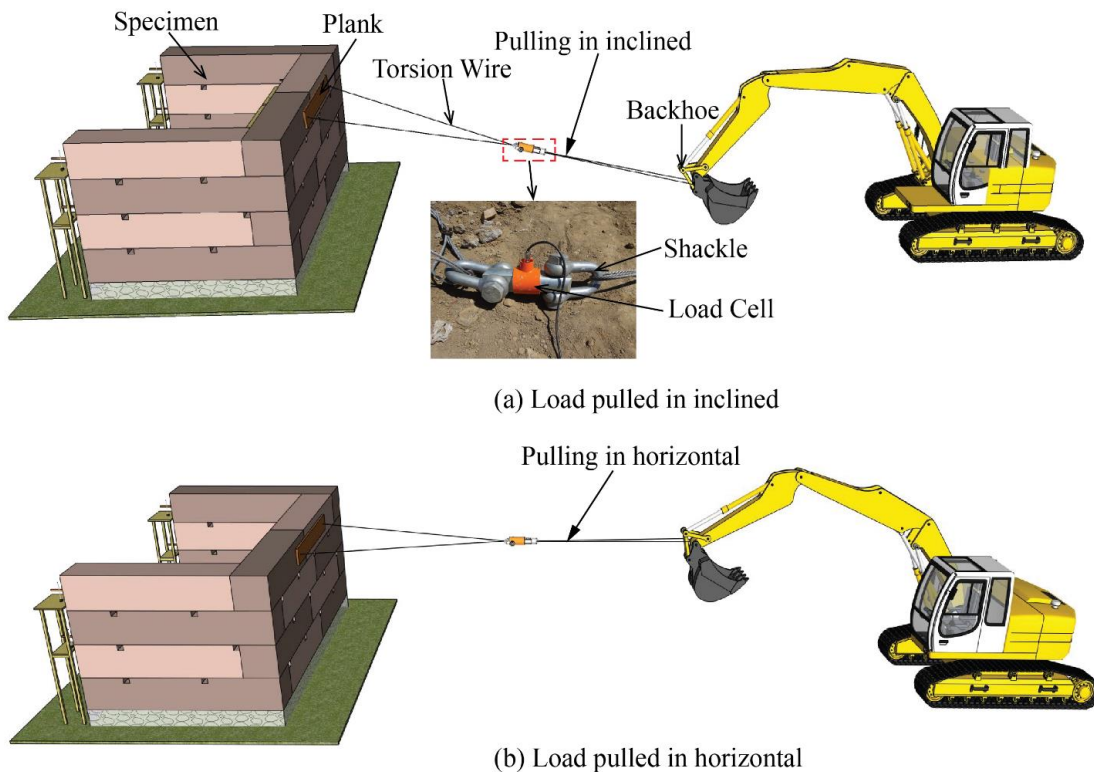
Figure 4.27 Overview of out-of-plane pull-down test.

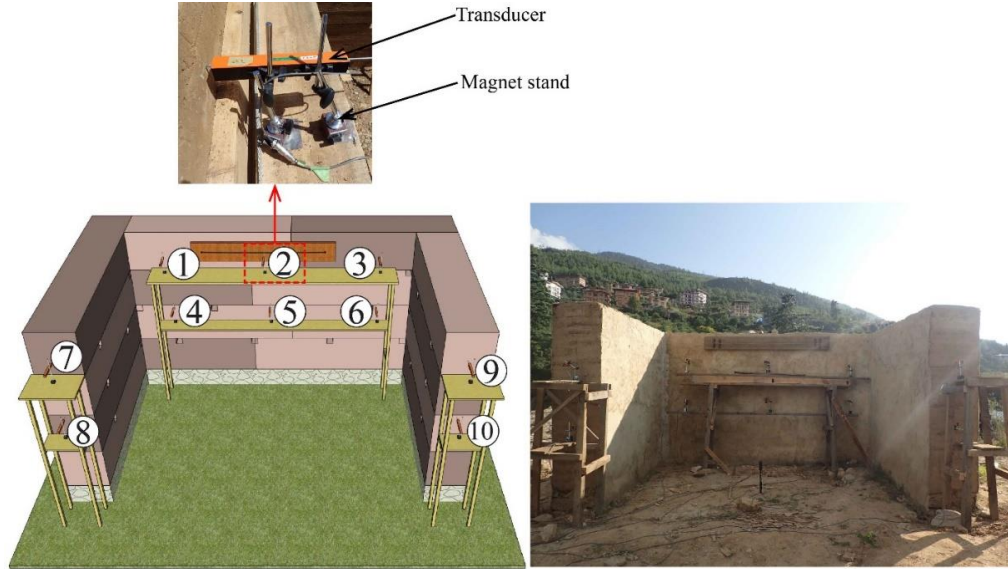
Figure 4.28 Location of transducers: 3D representation and on the field.

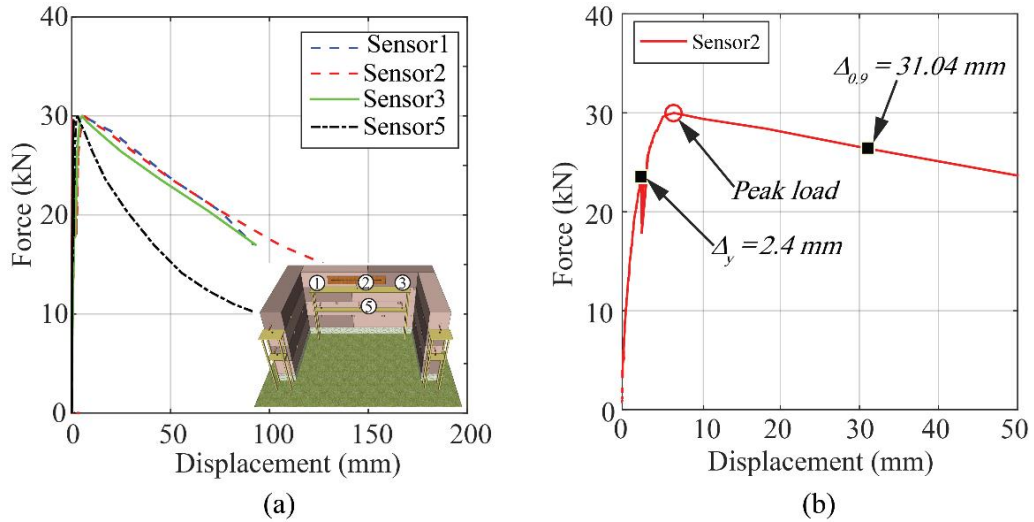
Figure 4.29 Load-displacement curve of U-RE: (a) Sensor 1,2,3 & 5; (b) Sensor 2.

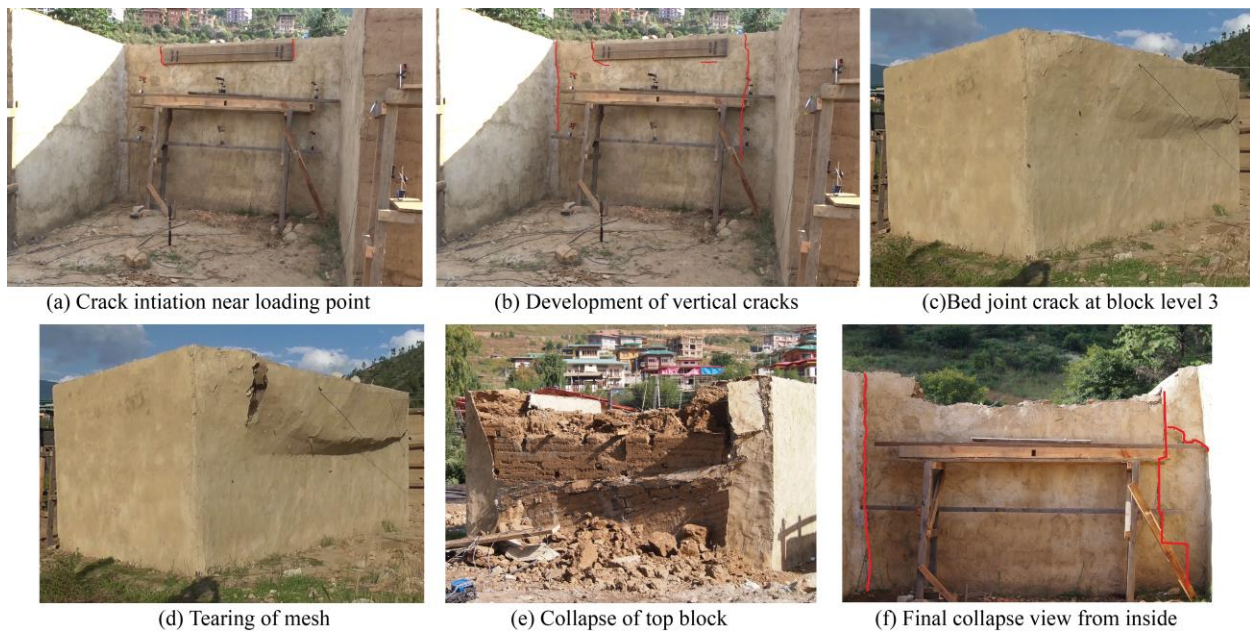
Figure 4.32 Failure mode of Mesh-RE.

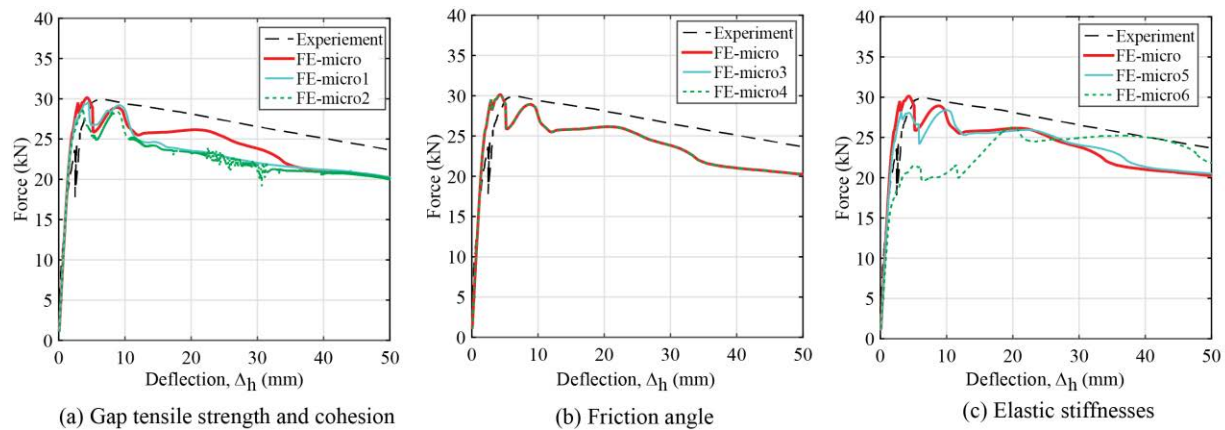
Figure 4.44 Pull-down force vs displacement for parametric study on micro models with variation in interface properties.

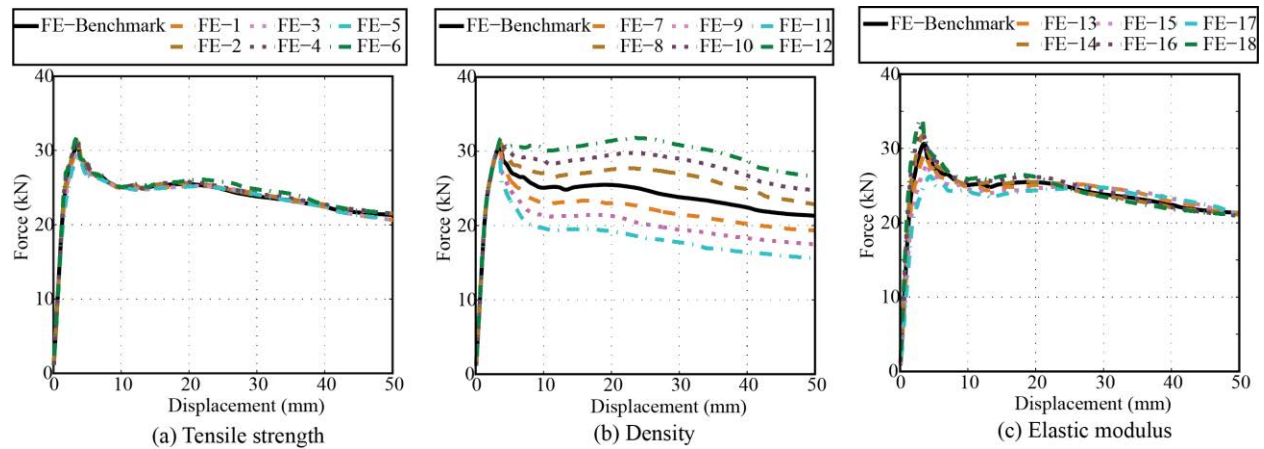
Figure 4.46 Pull-down force vs displacement for parametric study on micro models with variation in interface properties.

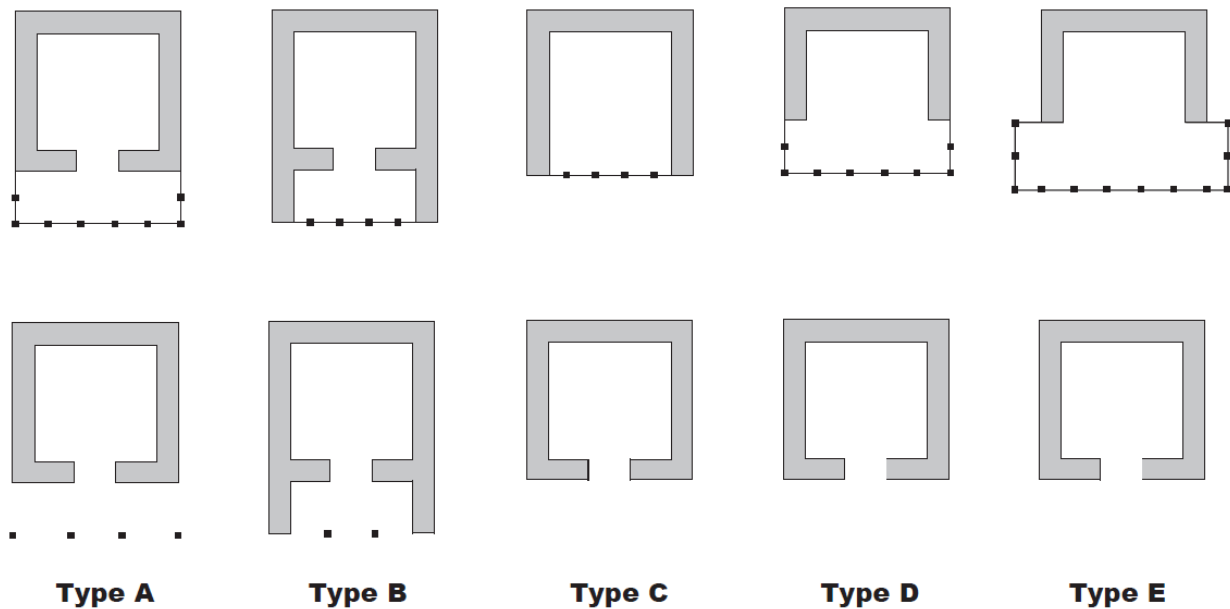
Figure 5.1 Classification of traditional houses based on the plans [4].

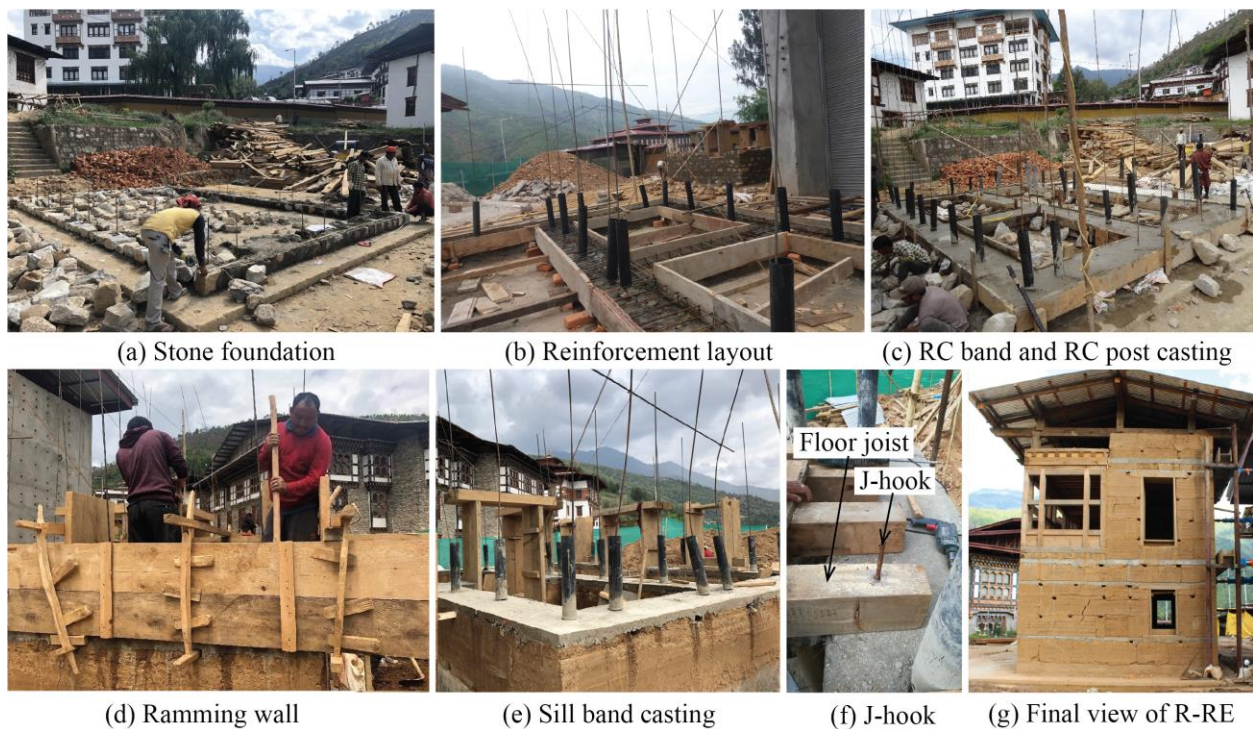
Figure 5.21 Construction process of New-RE-SHORT.
