**Seismic Vulnerability Assessment and Possible Strengthening  
Strategies for Traditional Bhutanese Rammed Earth  
Residential Houses**

**Phuntsho Wangmo**

A thesis submitted in partial fulfilment  
of the requirements for the degree of  
Doctor of Philosophy

Nagoya City University

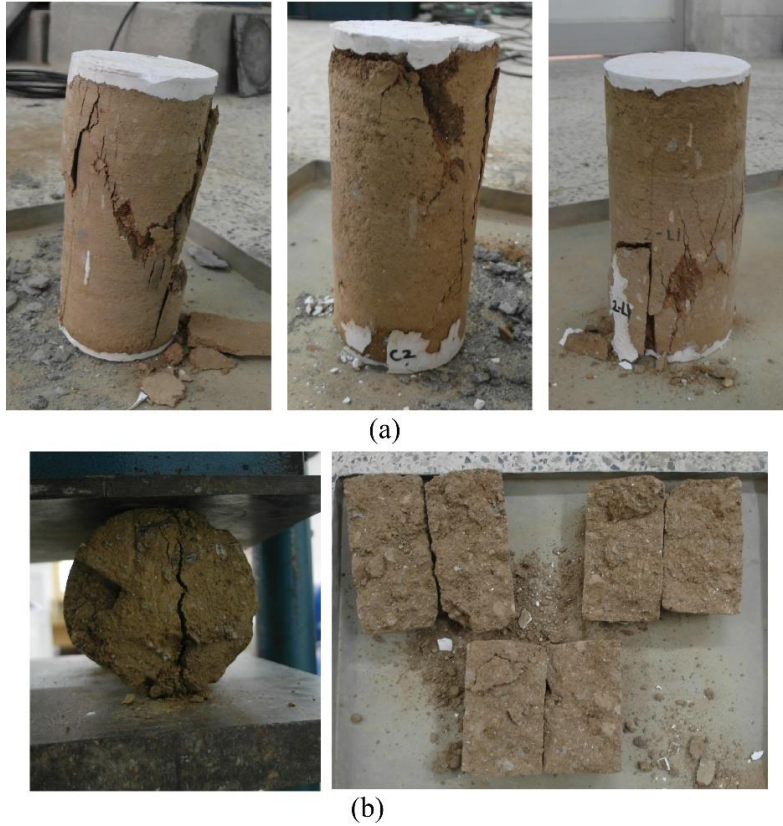
Figure 5.24 Failure patterns observed: (a) Compression test; (b) Tensile test.

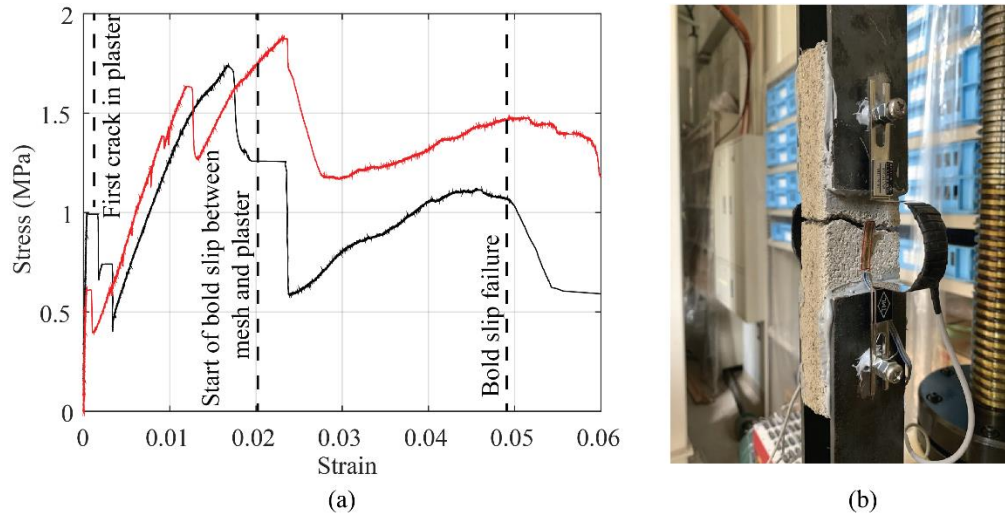
Figure 5.31 Tensile coupon test results: (a) Stress-strain curve; (b) Failure pattern.

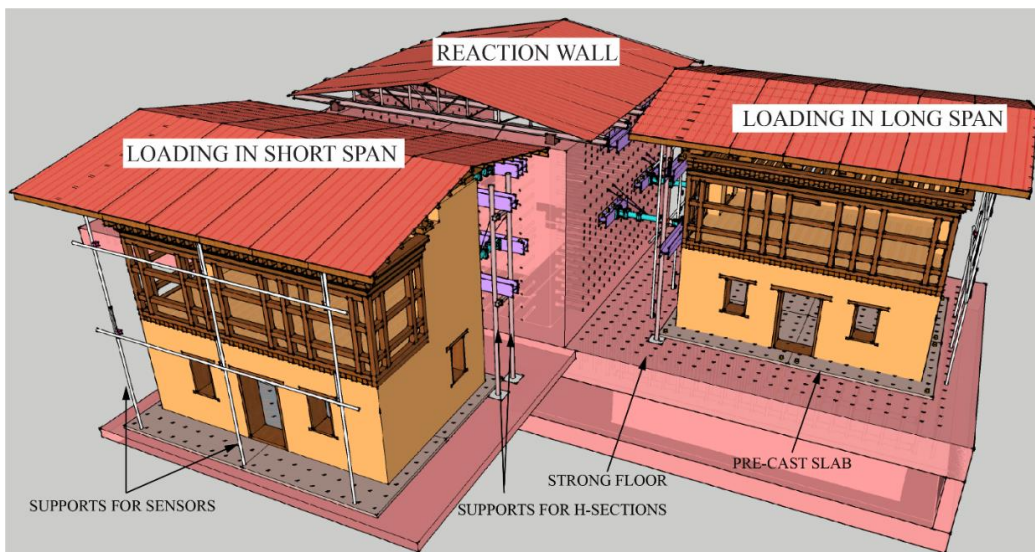
Figure 5.32 Overview of the fullscale test.

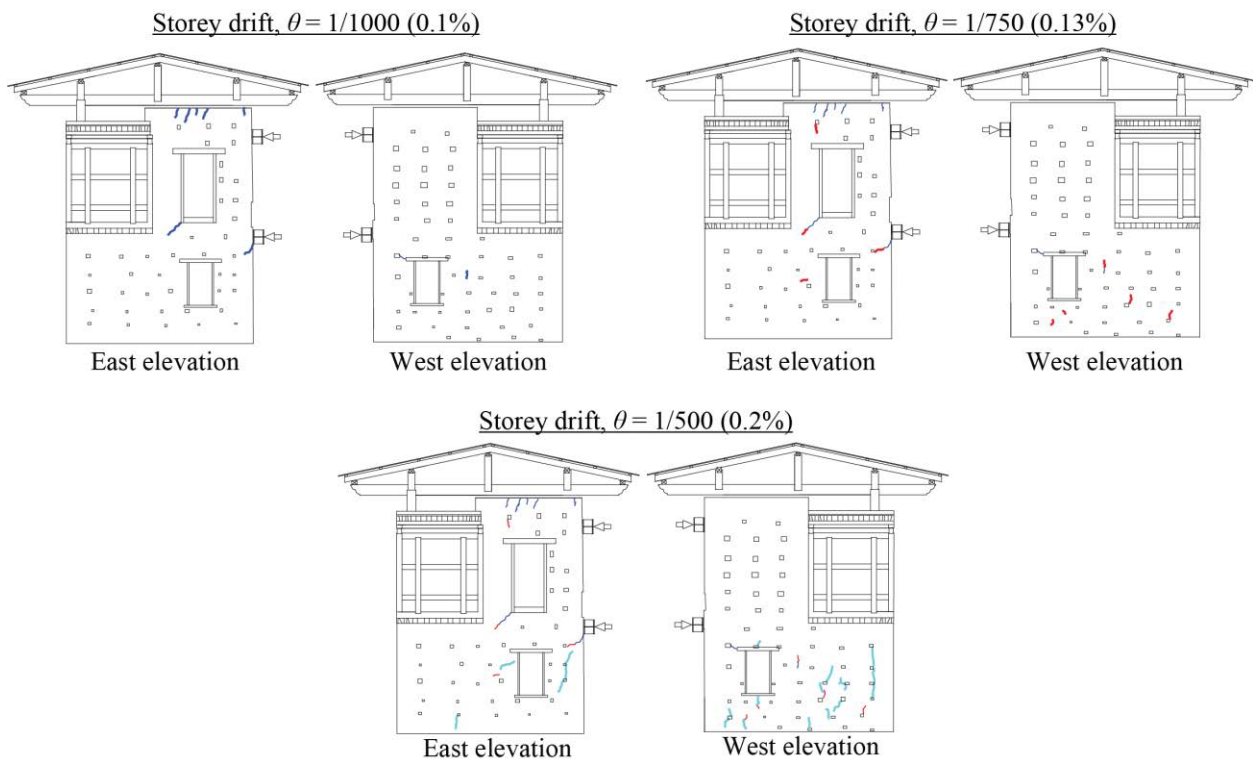
Figure 5.37 Failure mode of U-RE-SHORT.

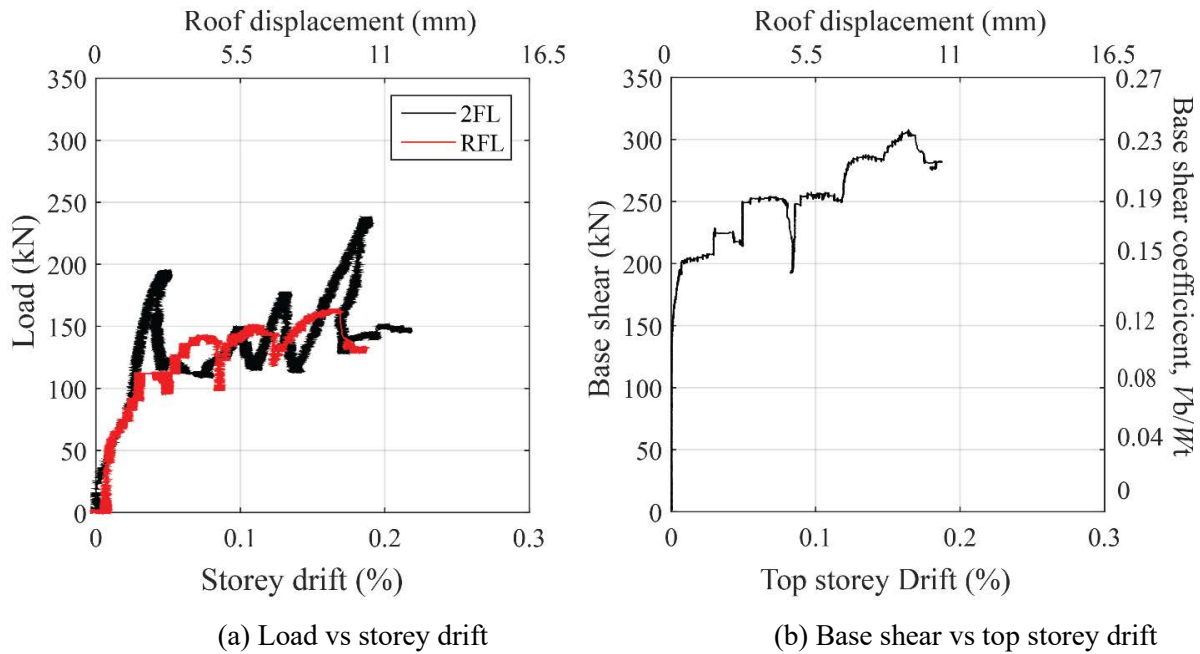
Figure 5.38 Capacity curve of U-RE-LONG.

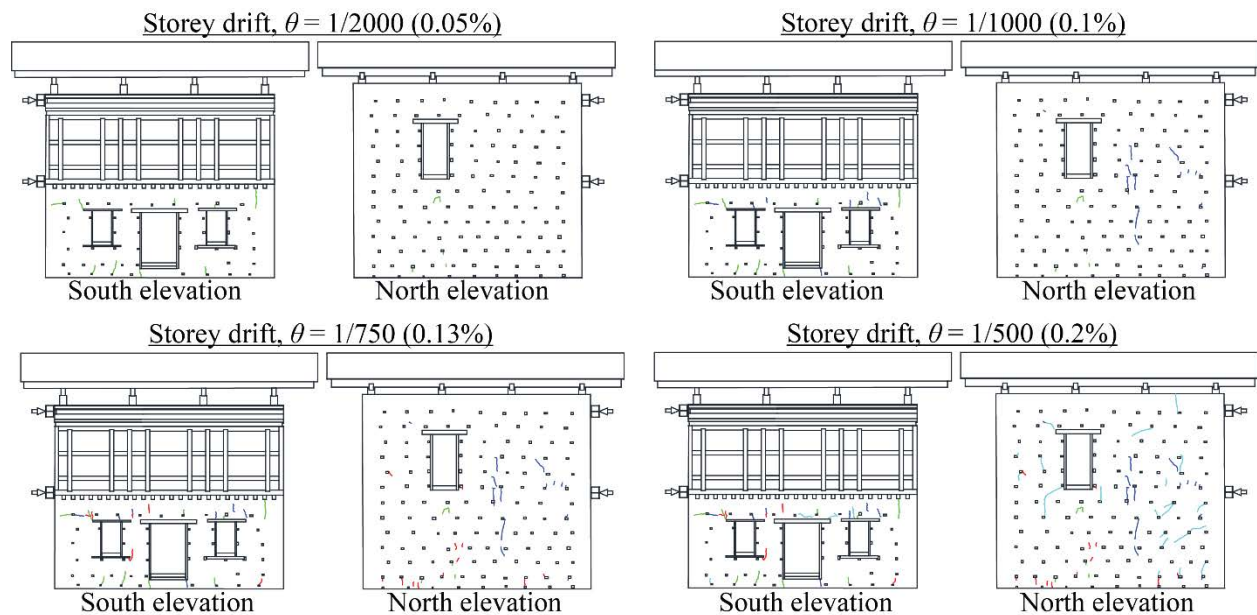
Figure 5.39 Failure mode of U-RE-LONG.

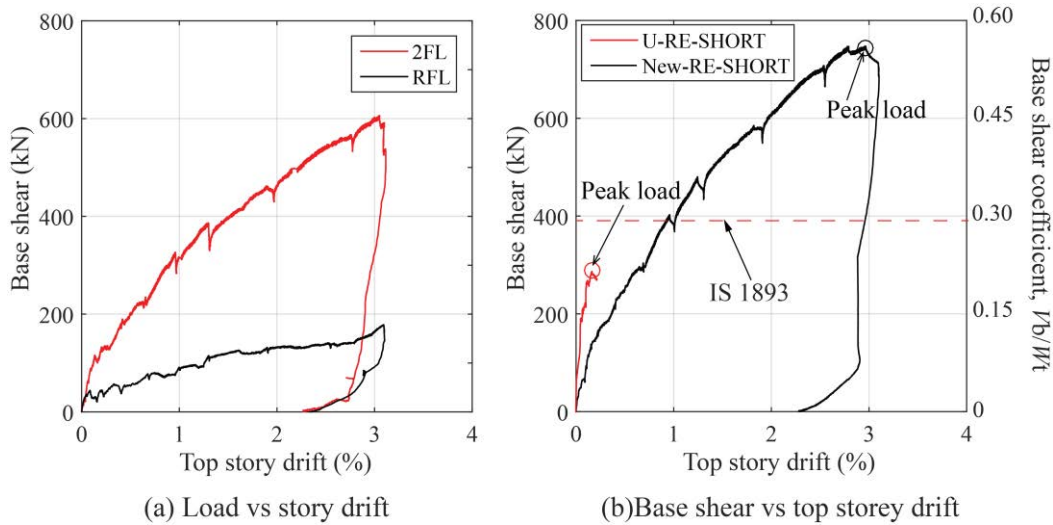
Figure 5.44 Capacity curve of New-RE-SHORT.

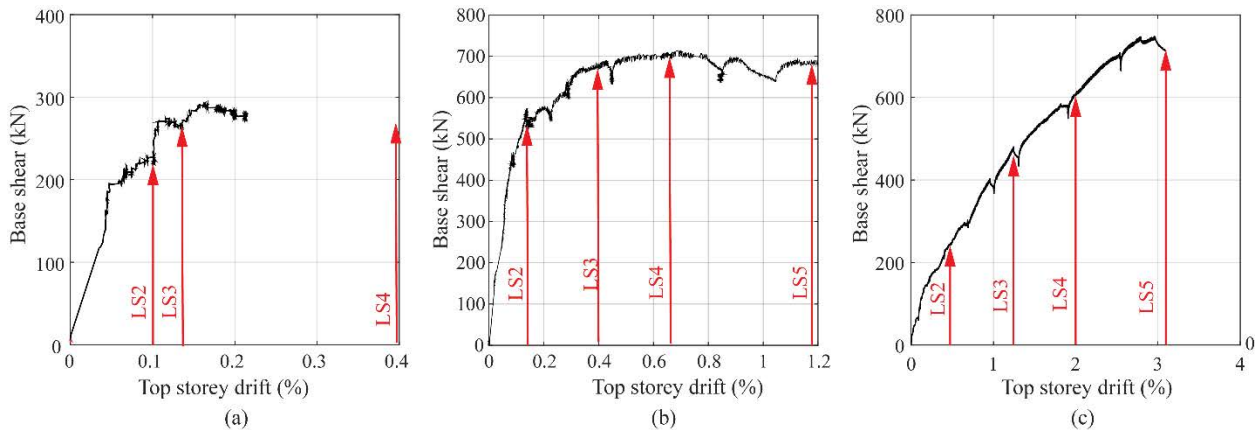
Figure 5.47 Limit states for: (a) U-RE-SHORT; (b) R-RE-SHORT; and (c) New-RE-SHORT.
